**Photographs – Franklin Branch Streambank Stabilization (Courtesy HRC)**

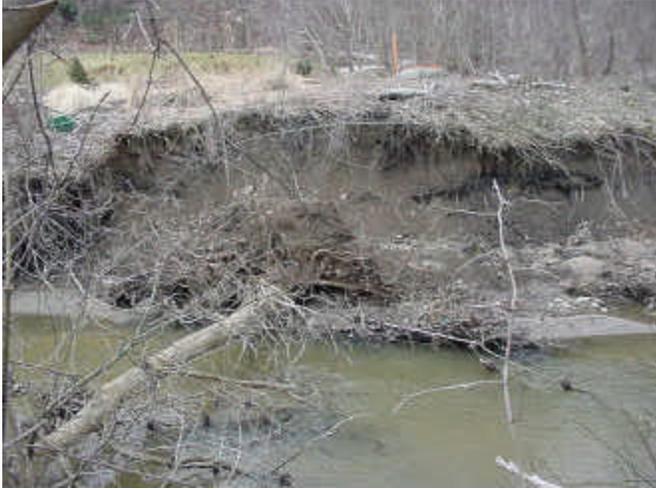
**Photograph 1:** Threatened sanitary sewer line in Area 2

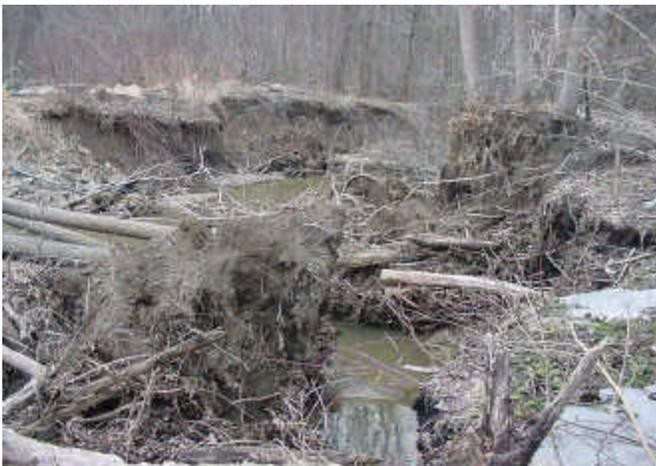
**Photograph 2:** Streambank erosion in Area 2, facing downstream

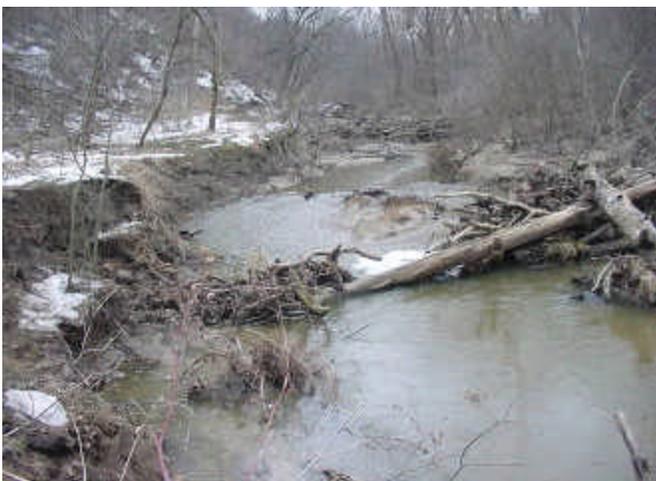
**Photograph 3:** Streambank erosion in Area 2, facing upstream

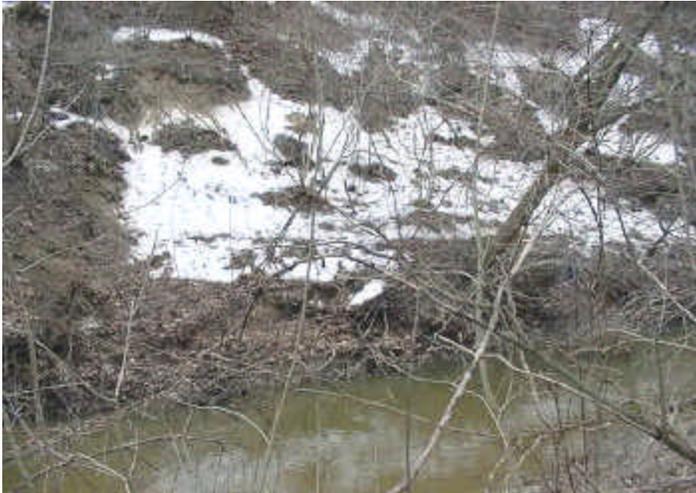
**Photograph 4:** Upper slope failure in Area 2 (1)

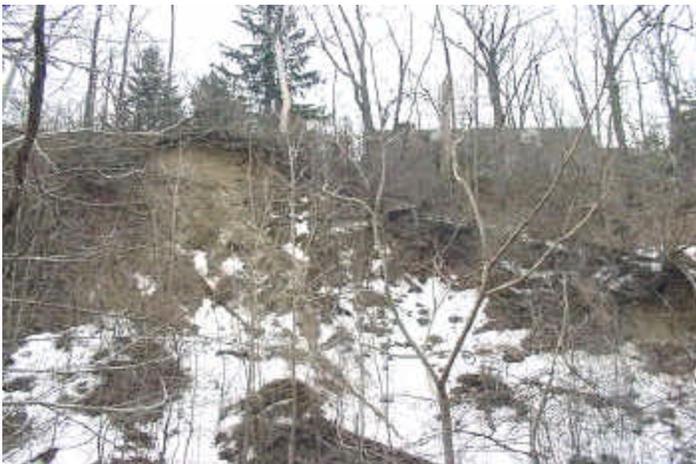
**Photograph 5:** Upper slope failure in Area 2 (2)

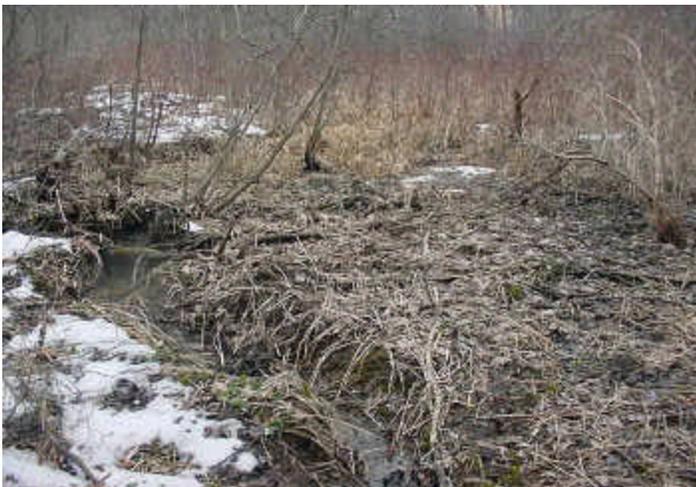
**Photograph 6:** Runoff from north side of the floodplain

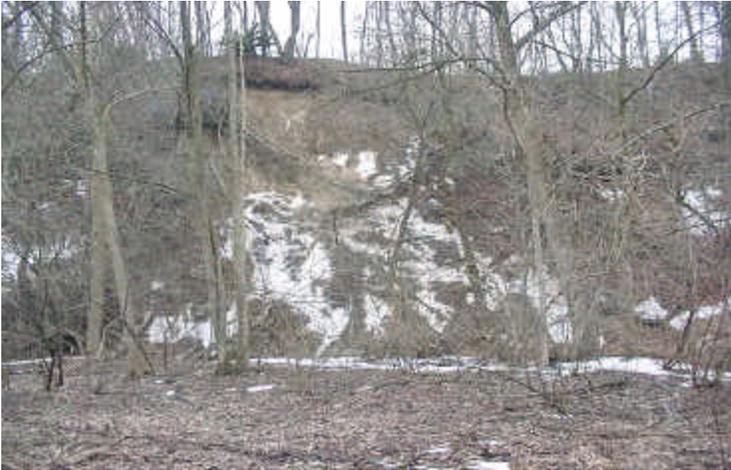
**Photograph 7:** Upper slope failure in Area 3 along 14 Mile Road

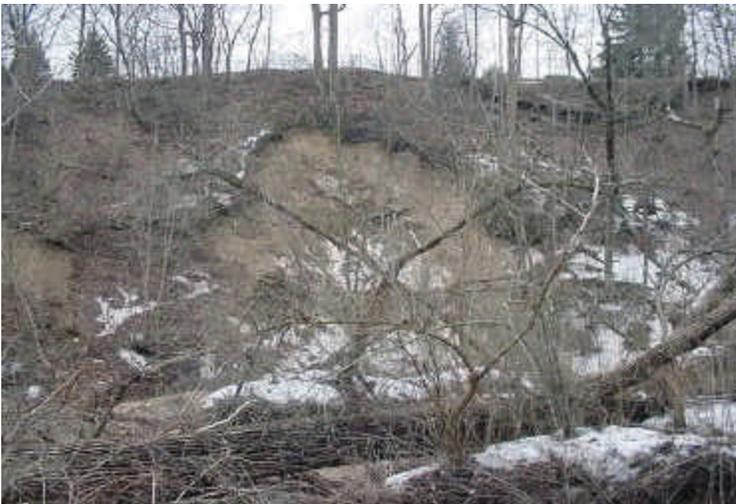
**Photograph 8:** Upper slope failure in Area 3 below 14 Mile Road

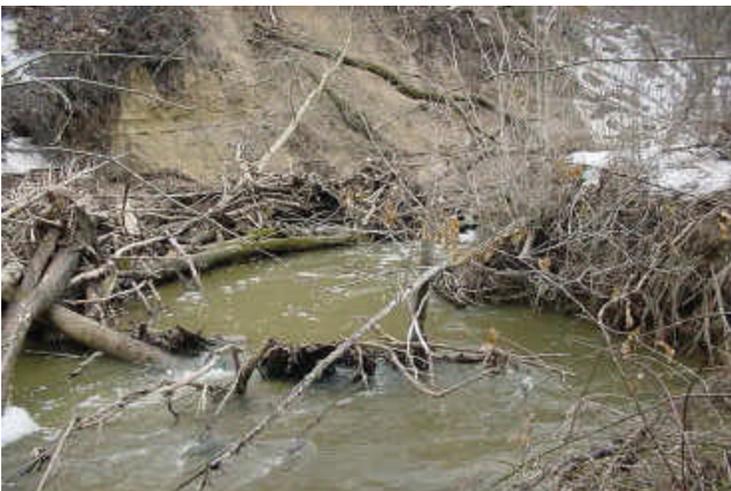
**Photograph 9:** Streambank erosion in Area 4, facing upstream

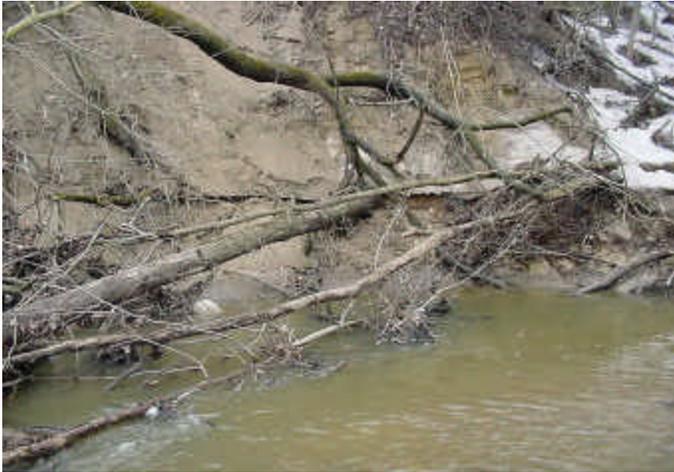
**Photograph 10:** Base of slope failure in Area 4

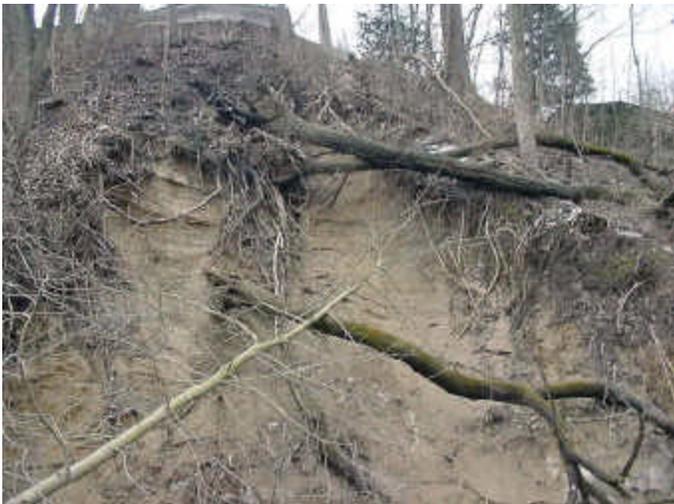
**Photograph 11:** Upper slope failure in Area 4 below 14 Mile Road
